This report prepared by Troy Townsend and Ray Siebring on May 17, 2013

The Aircraft

Category: E-LSA
Builder: Raymond Siebring / Aviation Education Initiative
Manufacturer: ITEC
Model: Maverick SP
Serial #: MS9003
FAA Registration: N94MV
Aircraft Total Time: 54.2 Hrs.

Investigation and Analysis

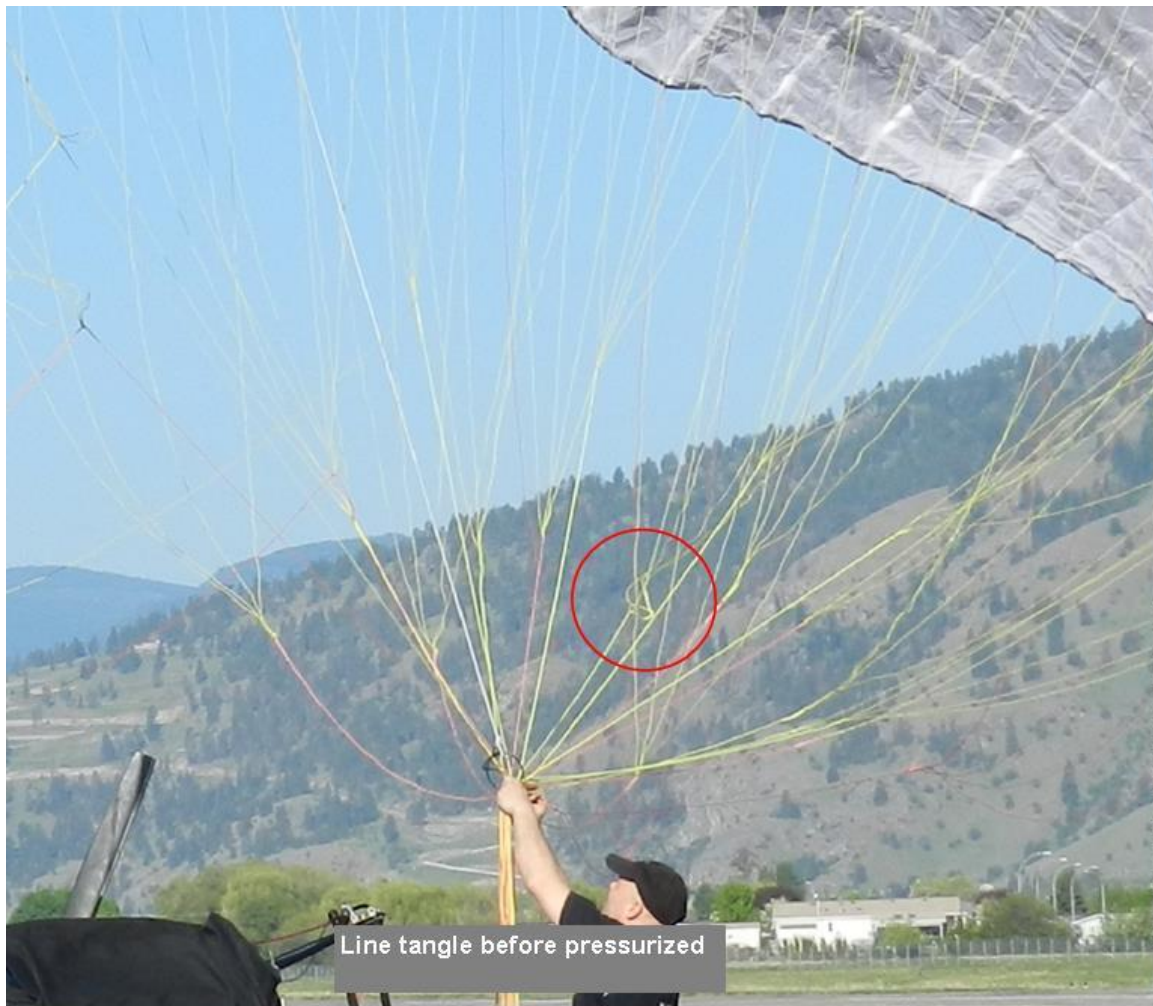
2. It was found by pictures, video and post flight inspection that a loop over or line was twisted on the left C3 lower line to an out board trailing line, essentially causing a large pressure not. This pressure knot caused a large wing deformation and dissymmetry of lift on the left side of the wing. This wing deformation on the left side of the wing caused the hard left turning tendency.

Picture 001 initial line tangle

1. It is essential that the POH (Pilot Operating Handbook) is followed during CG adjustment during wing setup.
2. On powered parachutes, it is essential that all lines are clear and tangle free before takeoff power is applied.
3. Completely verify you have a uniform flying wing before takeoff power is applied.
4. After airborne if problem is realized & if terrain allows, land straight ahead avoiding unnecessary turns.
5. When flying in mountainous areas, be critically aware of leeward downdraft and mountain wave possibilities.
6. When flying in the airport pattern environment, be critically aware of what other turbulence aircraft can produce, such as wingtip vortices.

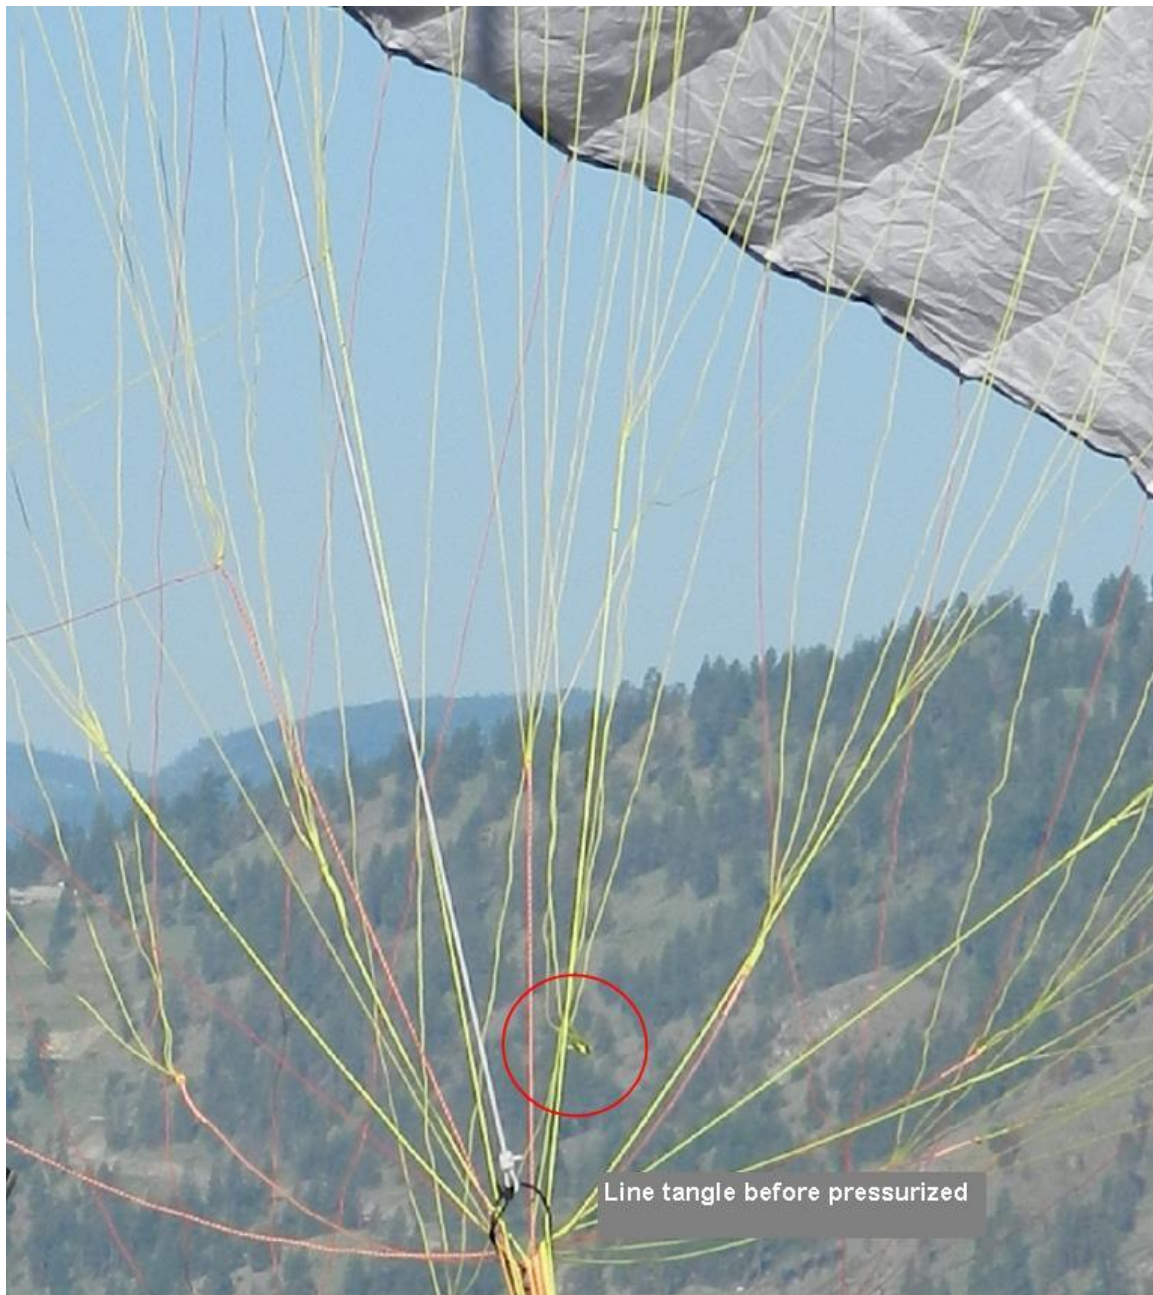
Picture 002 initial line tangle close up

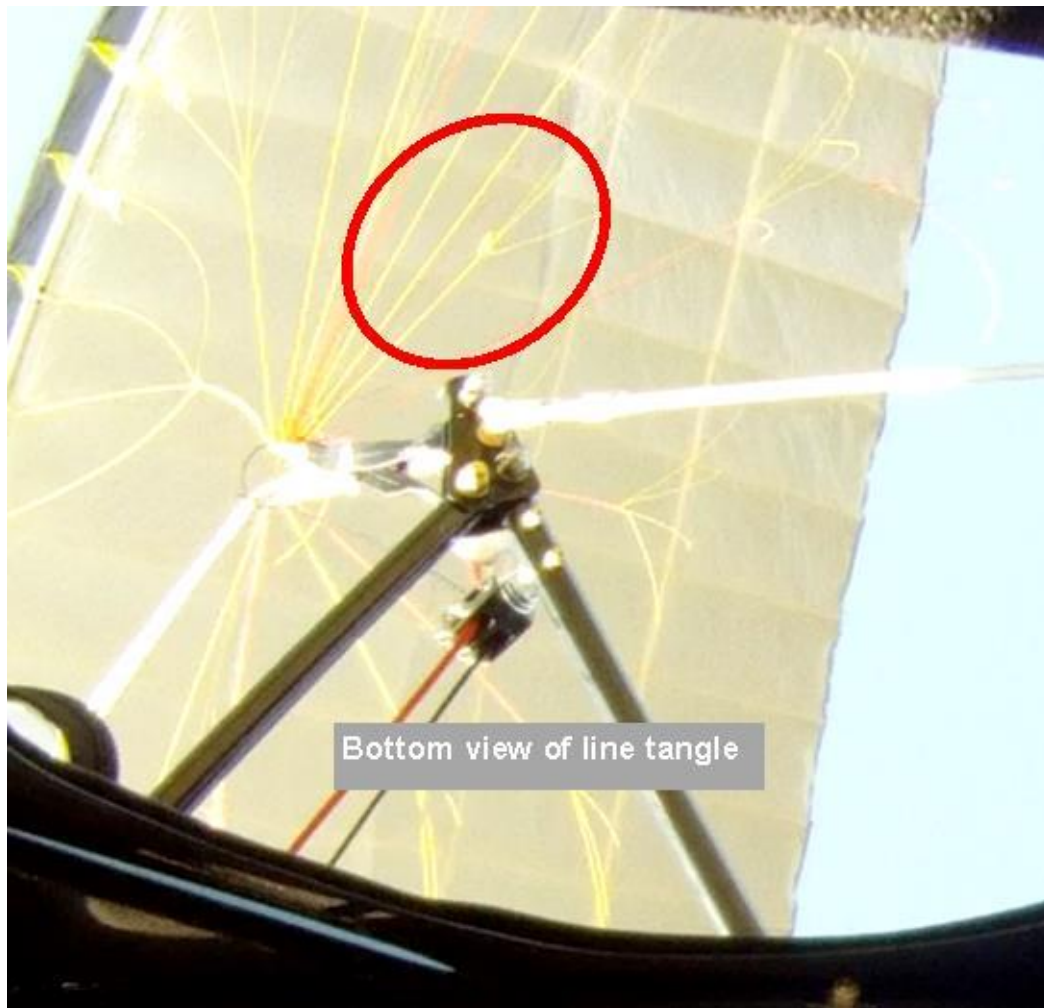
Picture 003 bottom (pilot) view of line tangle

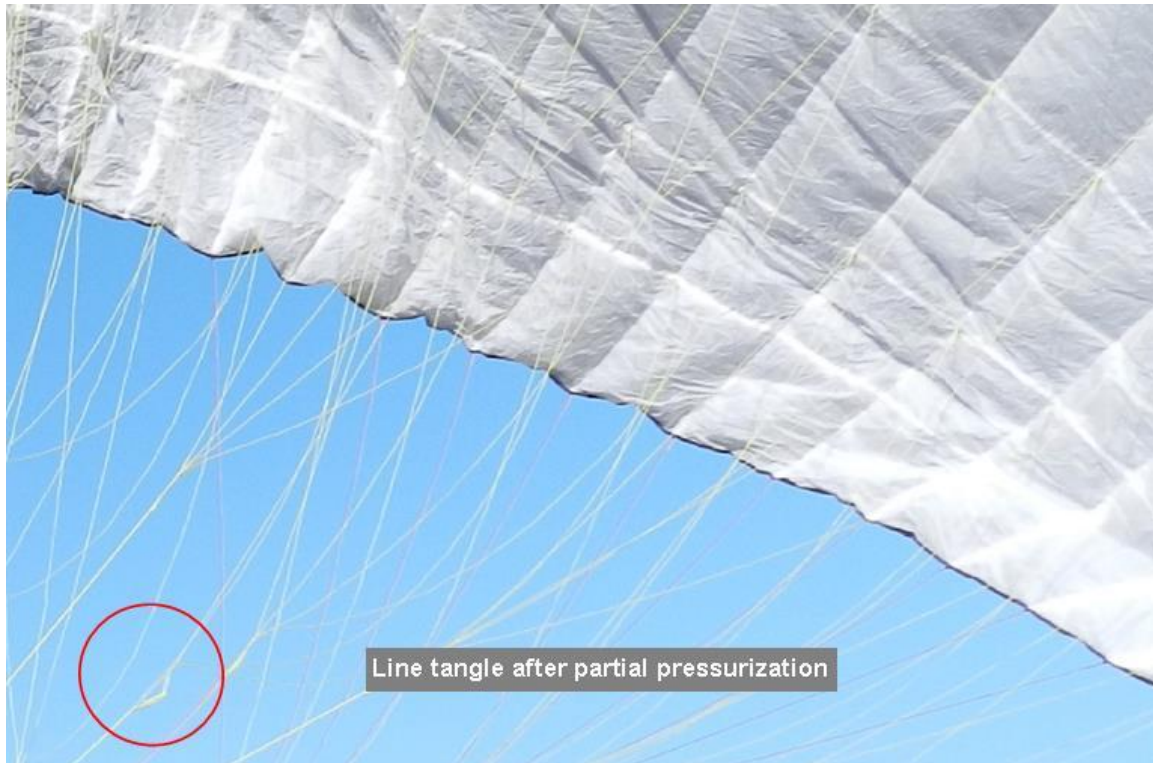
Picture 004 Partial pressurized line tangle

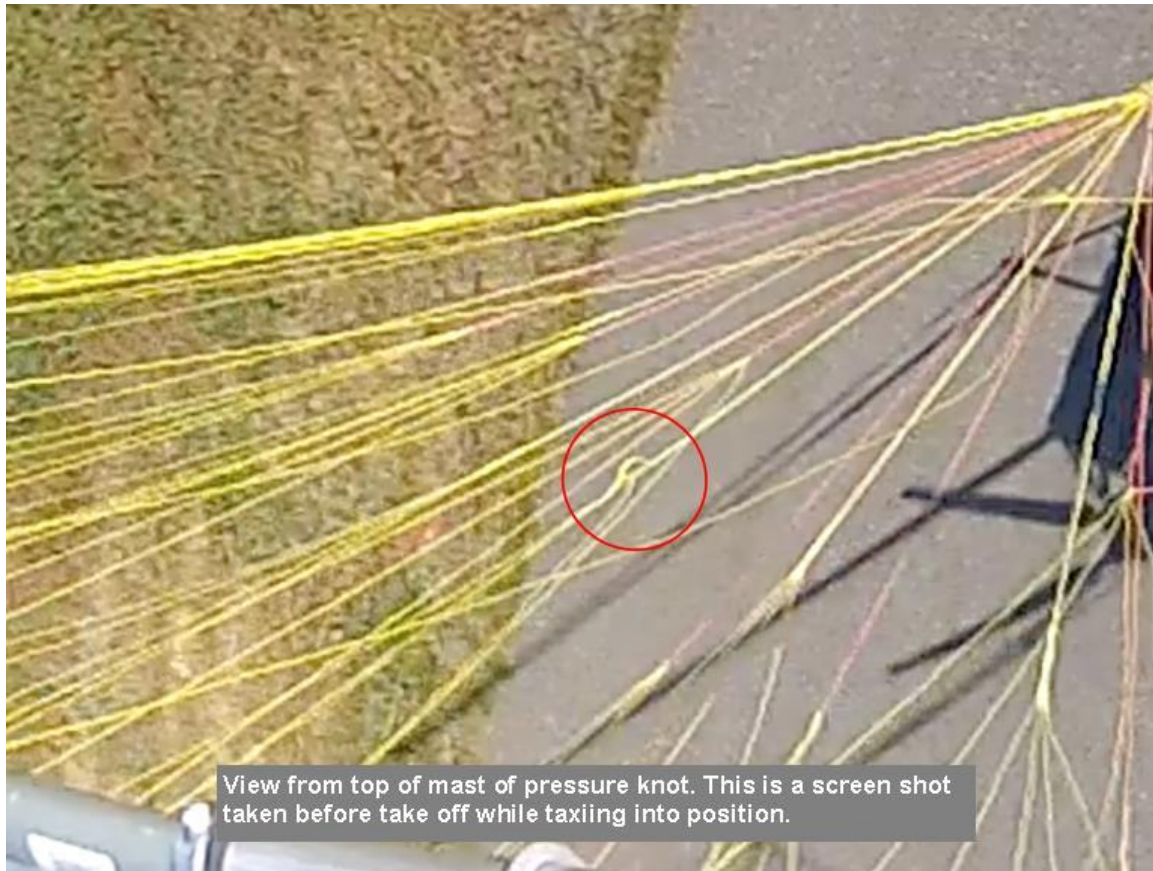
Picture 005 Mast view of tangle

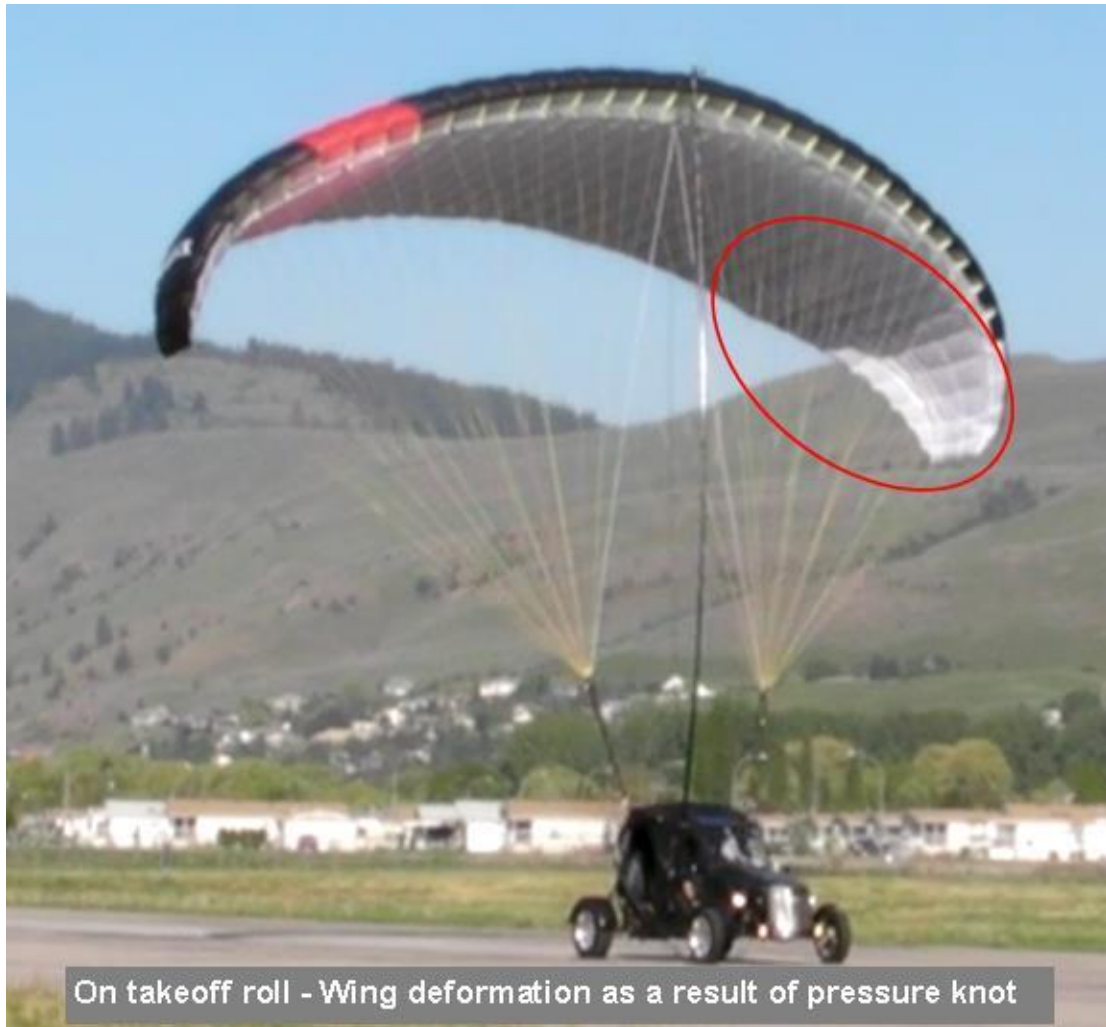
1. The twisted lines, deformed the left side of wing, caused a dissymmetry of lift resulting in a severe left turning tendency. The pilot then added right steering to arrest the turn. The aircraft was then flying in a flared condition causing low airspeed and a high power situation. This resulted in a dirty airfoil and unstable condition as the engine was using extra power to maintain altitude.

Picture 006 Wing Deformation

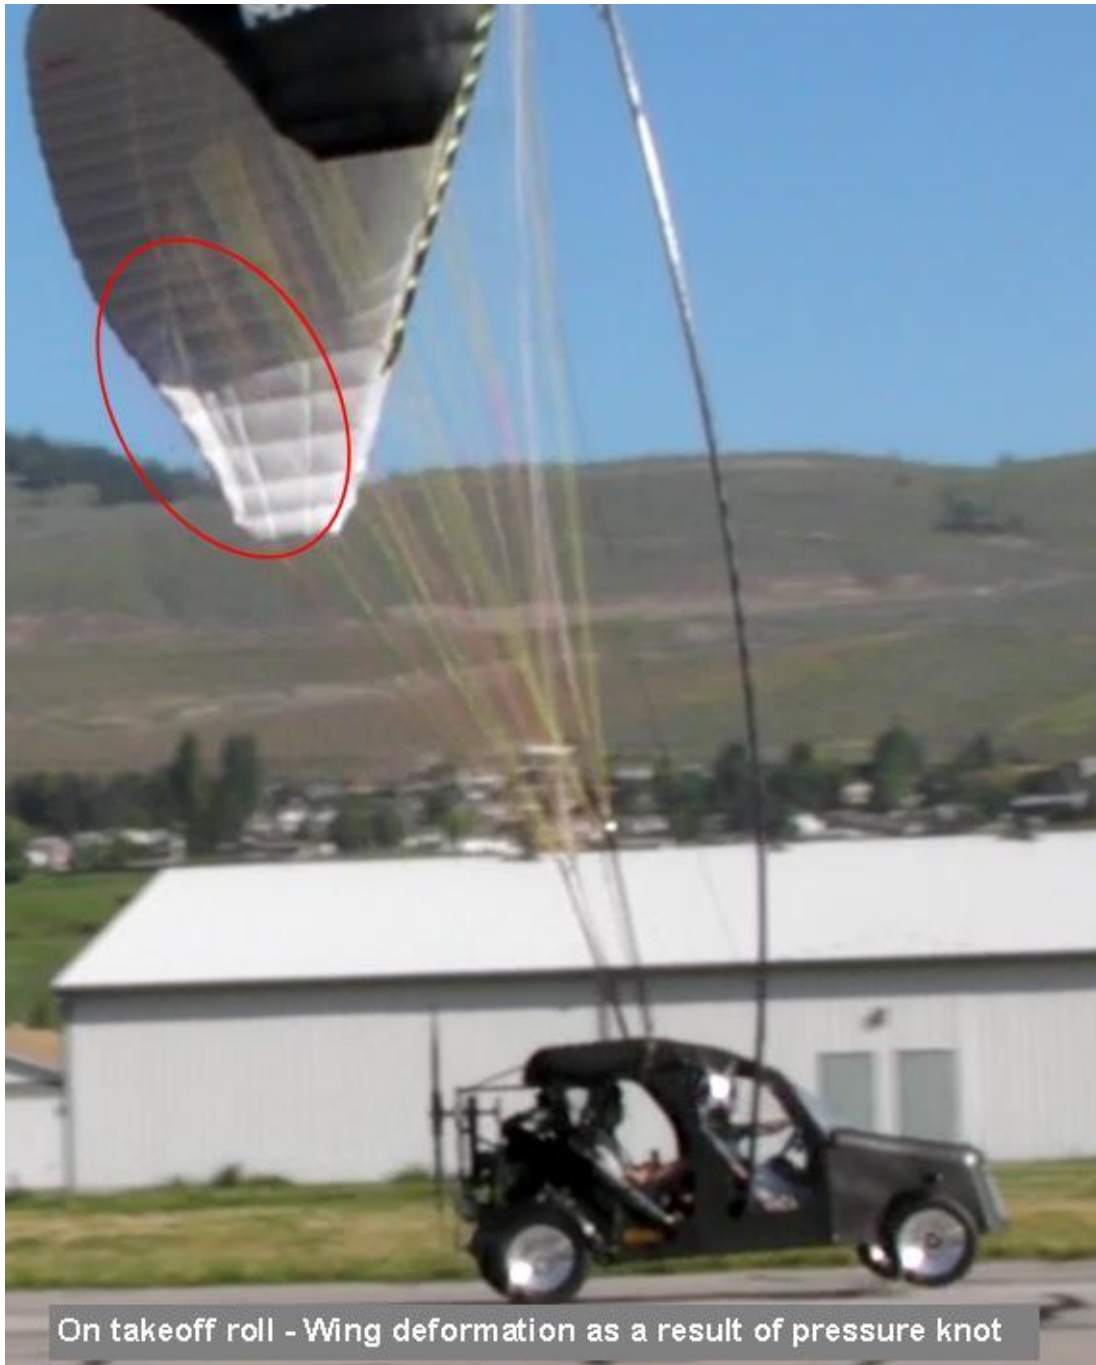
On takeoff roll - Wing deformation as a result of pressure knot

Picture 007 Wing Deformation Side view

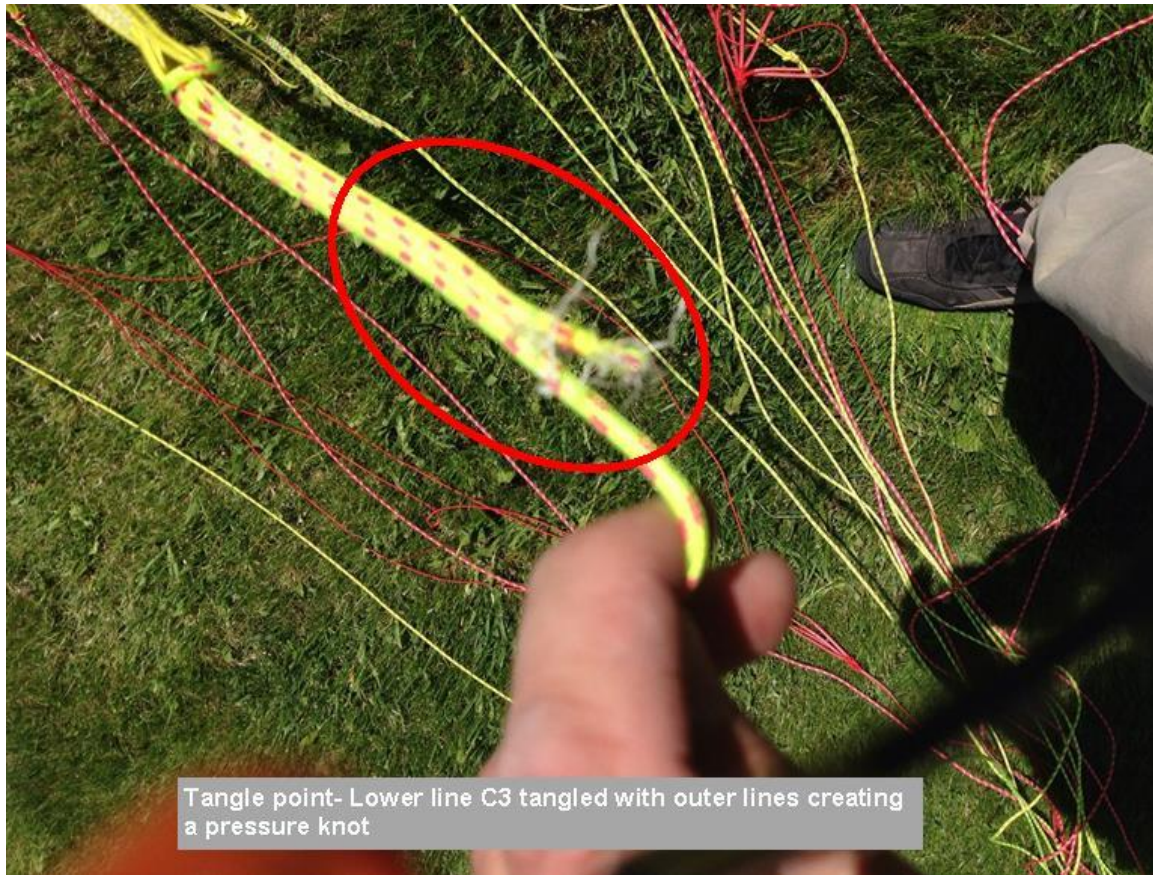
Tangle point- Lower line C3 tangled with outer lines creating a pressure knot

Picture 008 Post accident line analysis shows tangle point

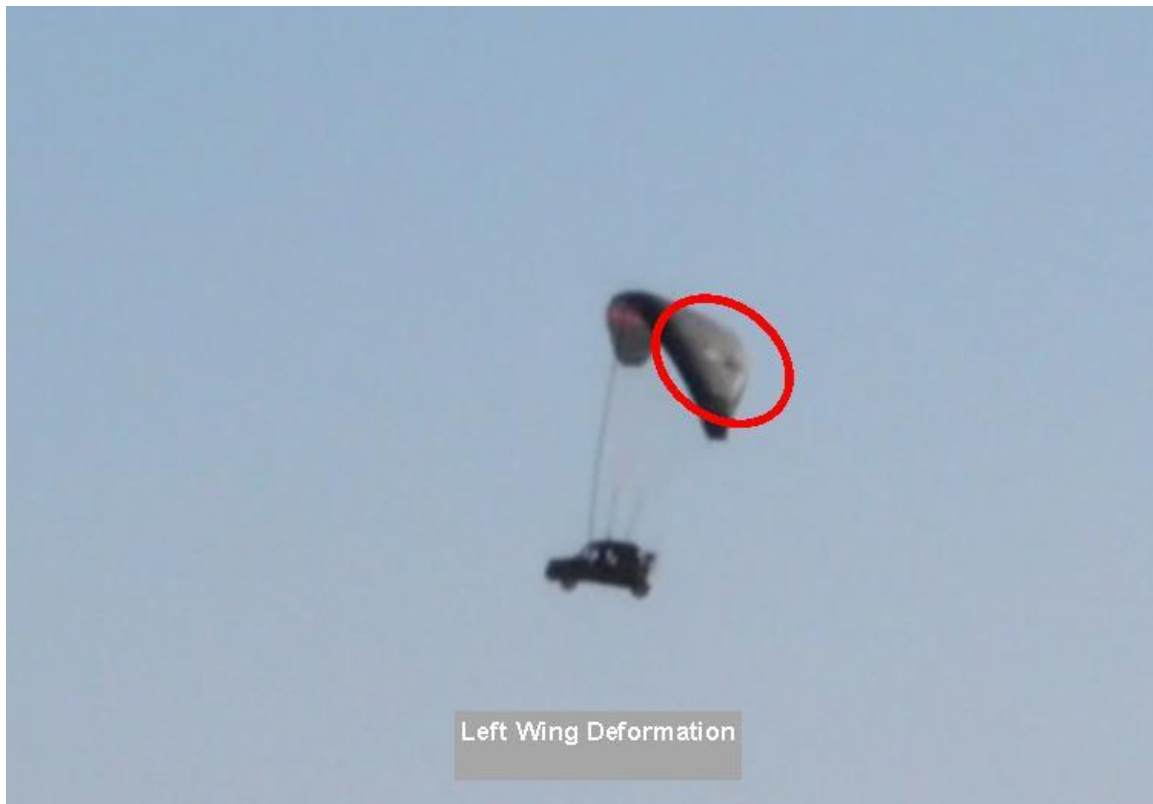
Picture 009 Dimple in left wing indicates how severe the wing deformation was

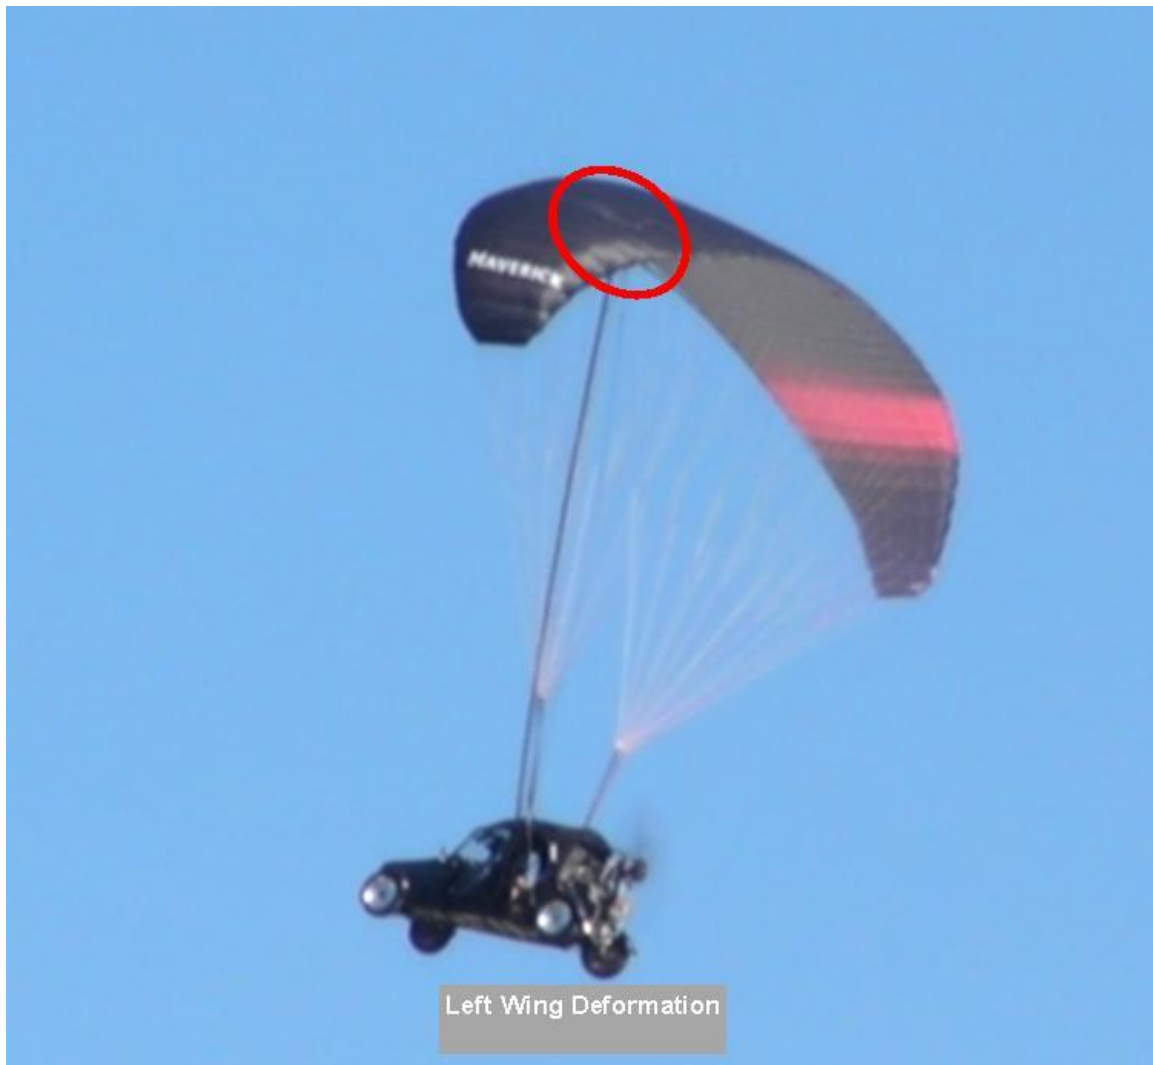
Picture 010 Left wing deformation closer view

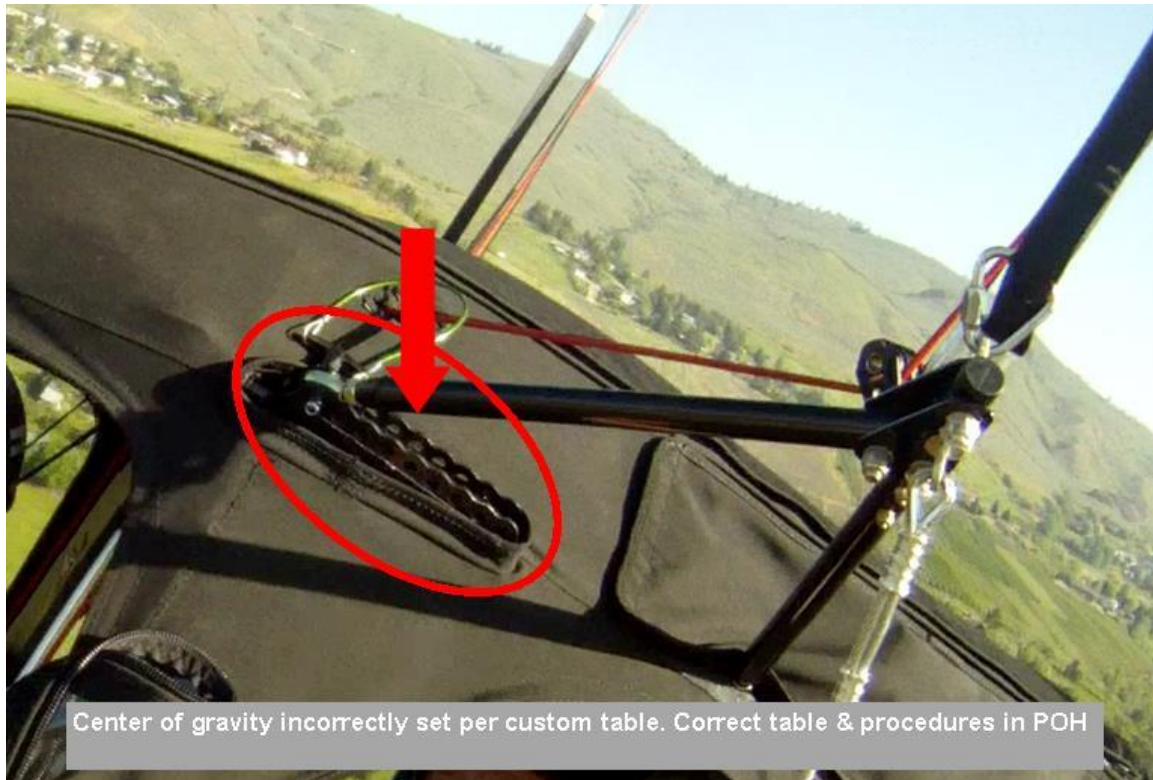
1. It was found by pictures, video and post flight inspection, that the aircraft was out of CG for pilot weight and not set properly per POH. Incorrect CG setting were referenced from a custom chart pilot had and resulted in a nose high attitude.

2. The center of gravity was adjusted incorrectly causing a higher nose up attitude. This resulted in an unstable condition as the engine was using extra power to maintain altitude because of incorrect line of thrust.

Picture 011 Incorrectly set CG arm created a higher than normal nose high attitude. Arrow points to the proper selection of CG hole.

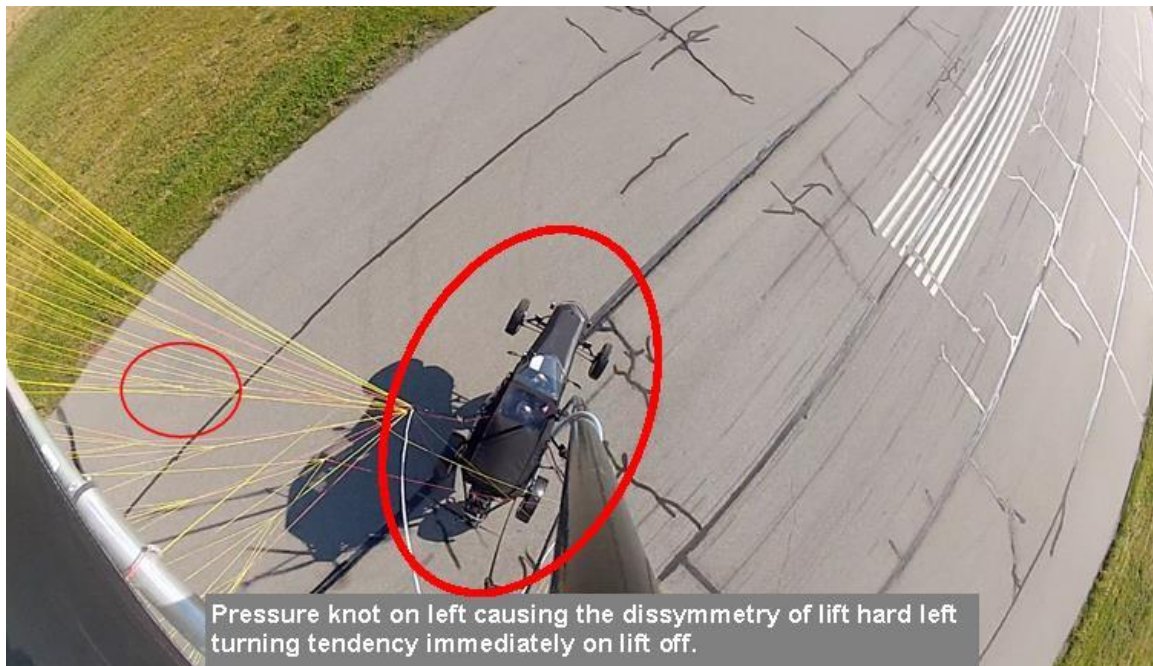
Picture 012 Initial take off and immediate left turning tendency

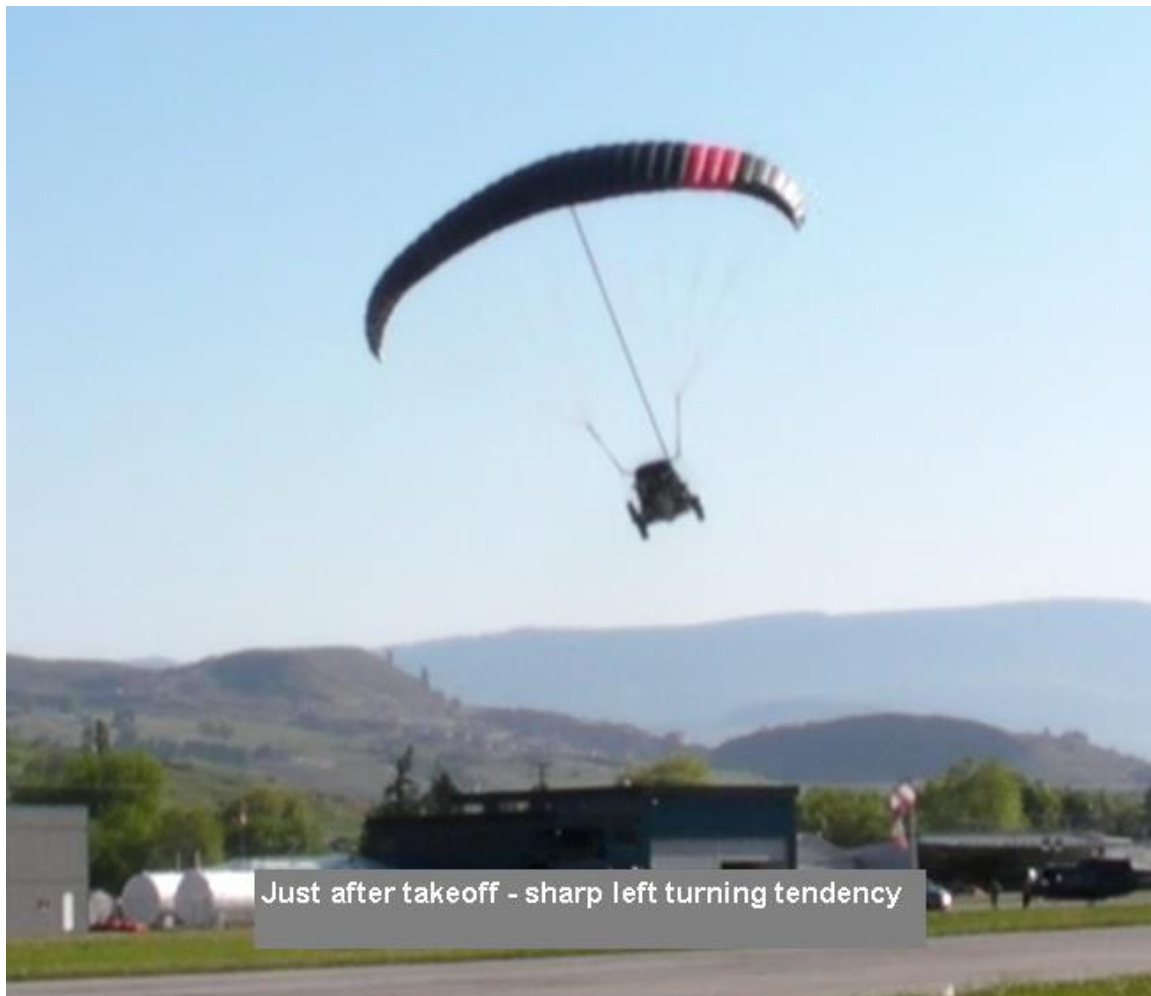
Picture 013 Shortly after take-off and immediate left turning tendency

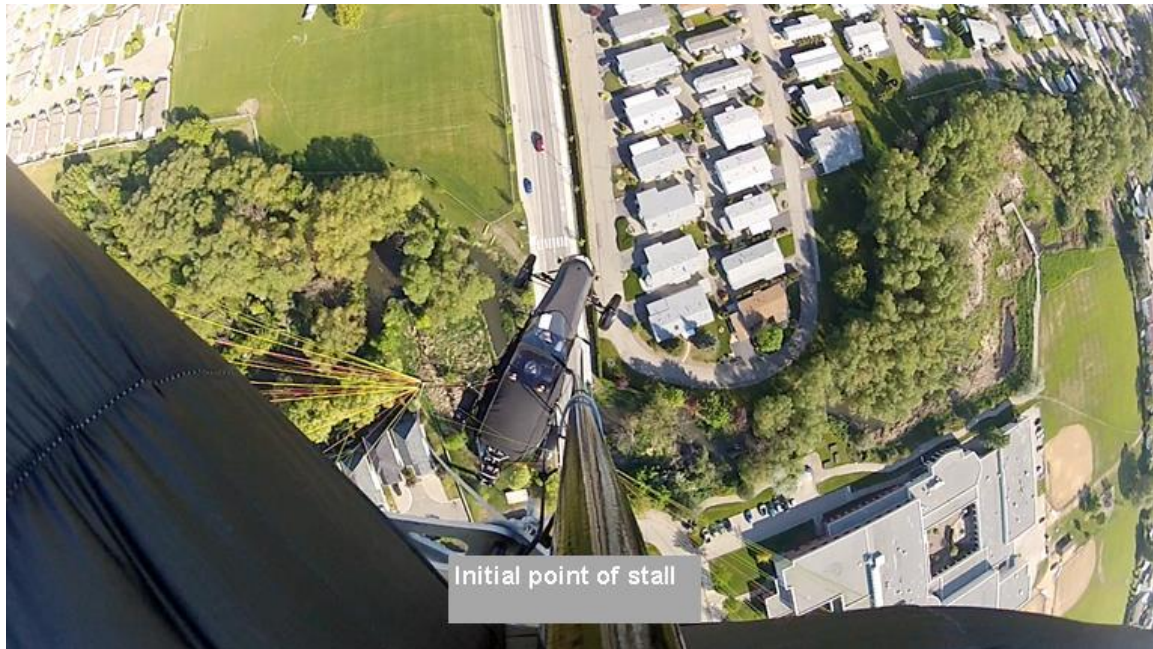
3. It was observed by pictures and video that disturbed air was encountered as indicated by a sudden change in wind noise, engine noise and ground track. This disturbed air may have been mountain ridge turbulence from leeward side but its exact source is not known. This disturbed air was the final cause that induced the un-commanded left turn stall / spin.

3. Turbulence was verified at the time of the stall from video. The aircraft was flying in an almost stalled configuration, a turn or turbulence is believed to be the last event that put the aircraft in a stall resulting in a single rotation incipient spin.

Picture 014 Video reveals a sudden sound difference in the wind and a loss of forward ground track. The shift in the wind results in the stall / spin

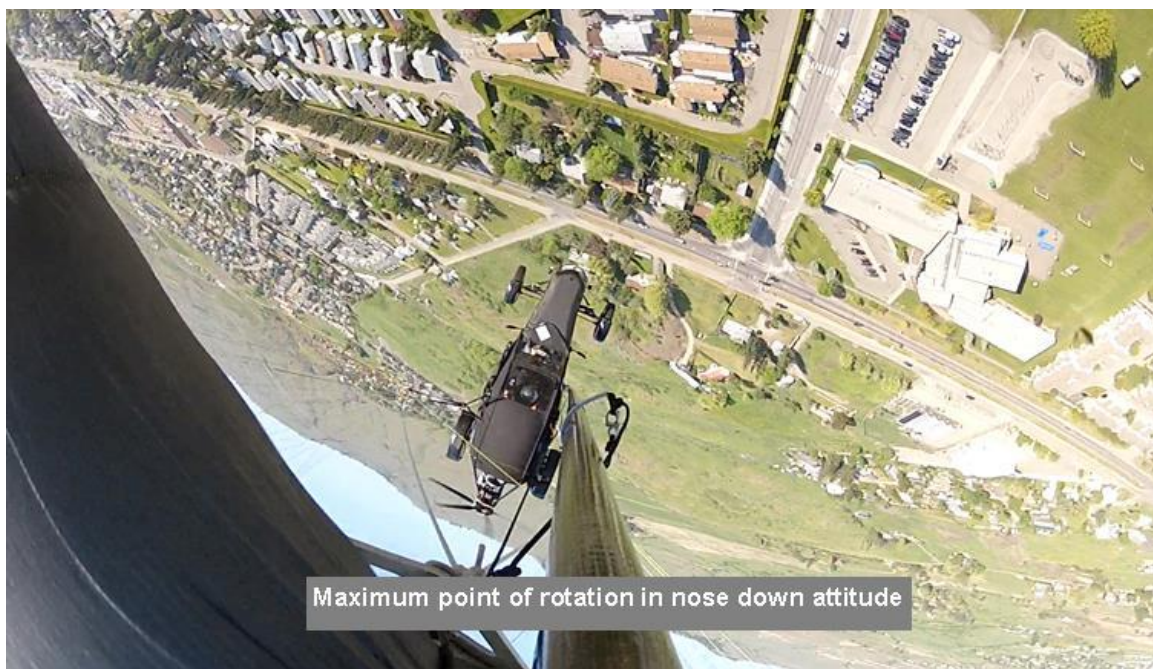
Picture 015 Stall / Spin developed quickly and immediate full power and opposite controls were applied even before full development was complete.

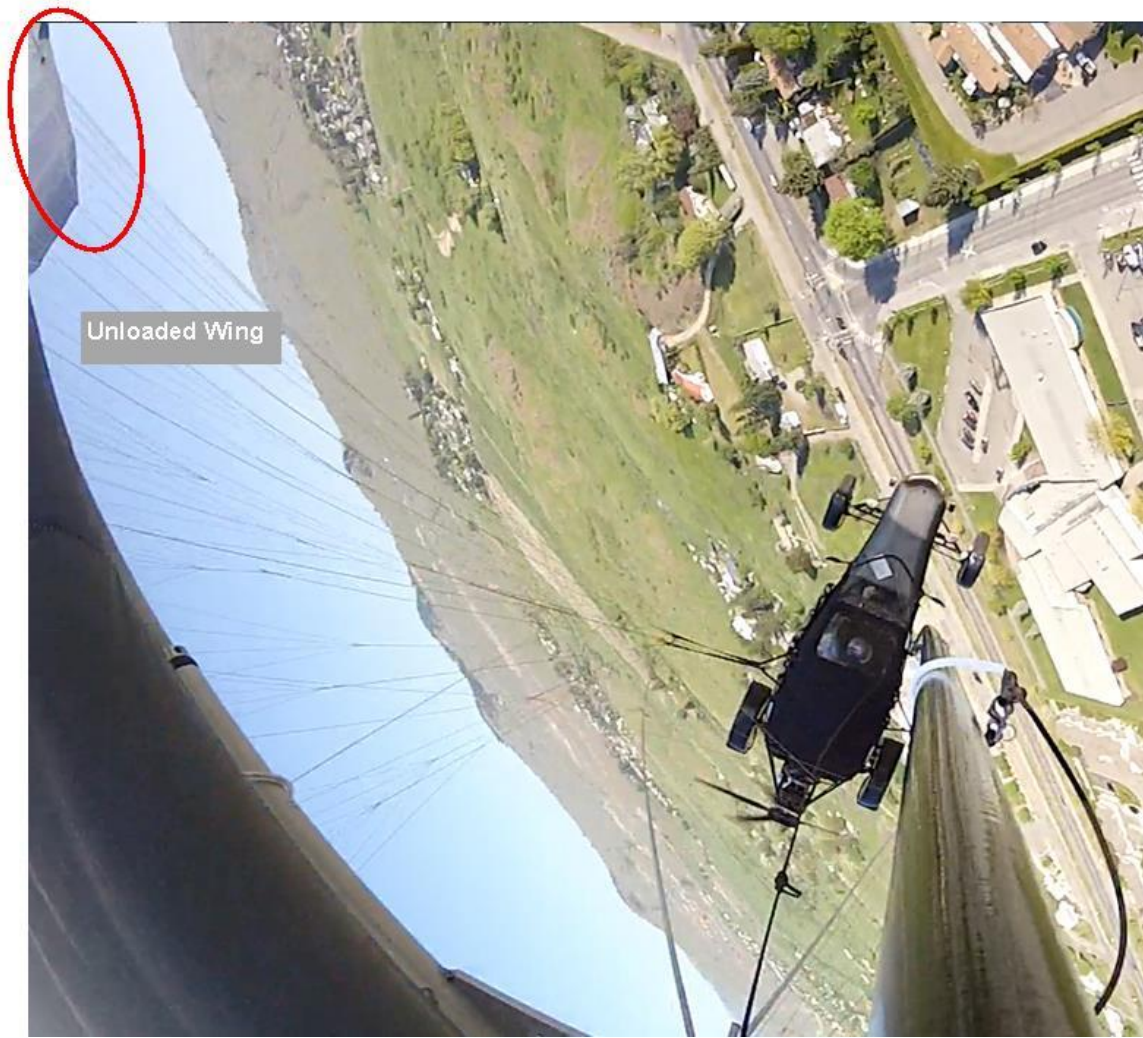
Picture 016 Unloaded Wing in stall

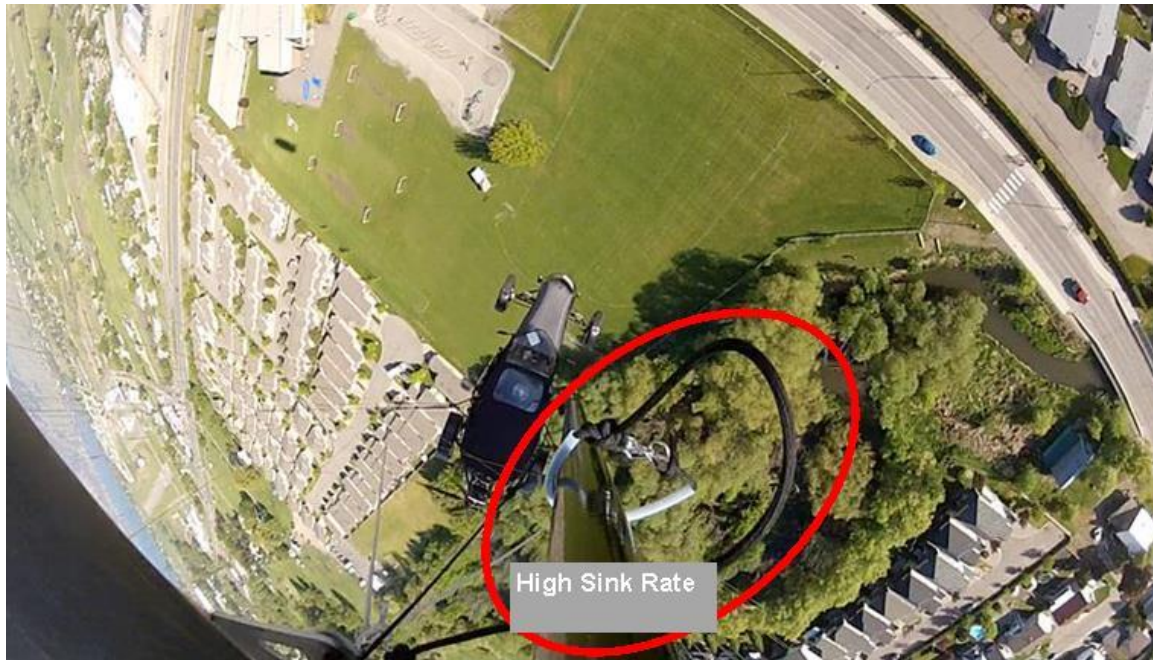
Picture 017 Retaining ring floating up illustrates the high sink rate experienced

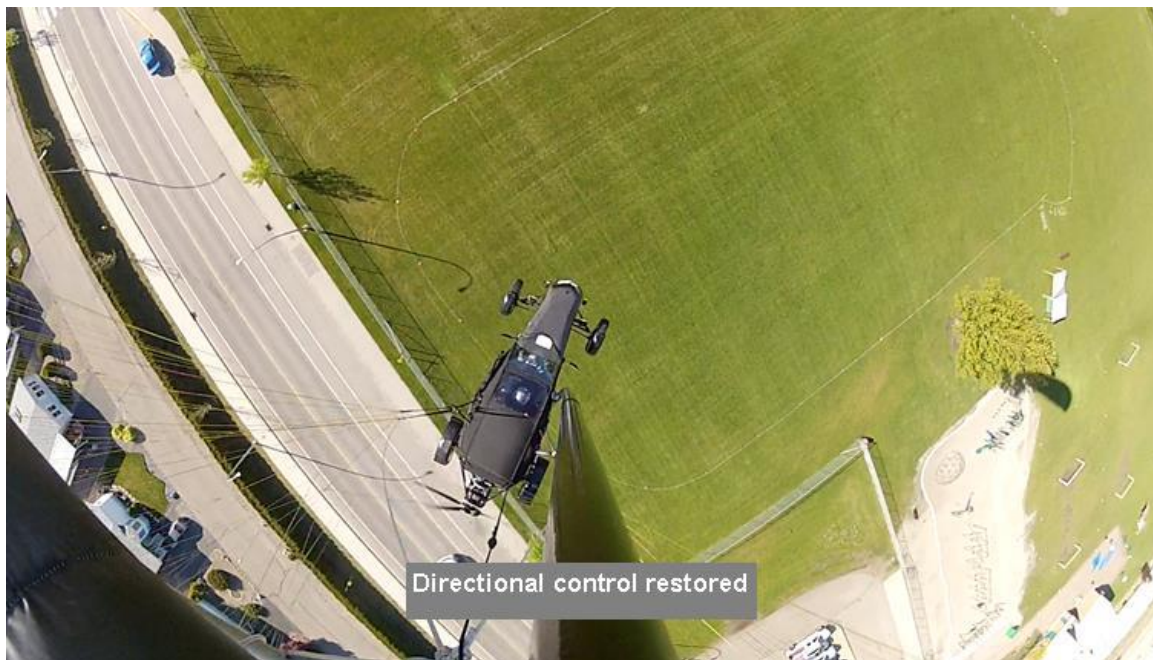
Picture 018 Directional control restored but at high sink rate & critically low altitude, choice of impact zone is made.

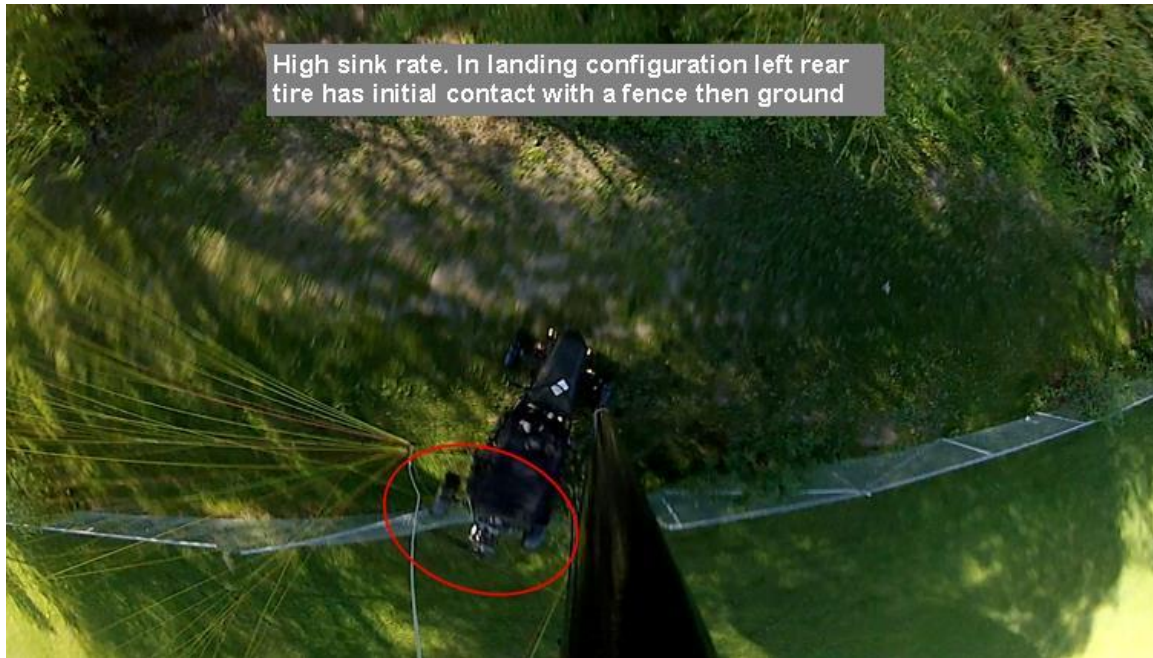
Picture 019 At a high sink rate but in a landing configuration, aircraft impacts fence with rear left tire

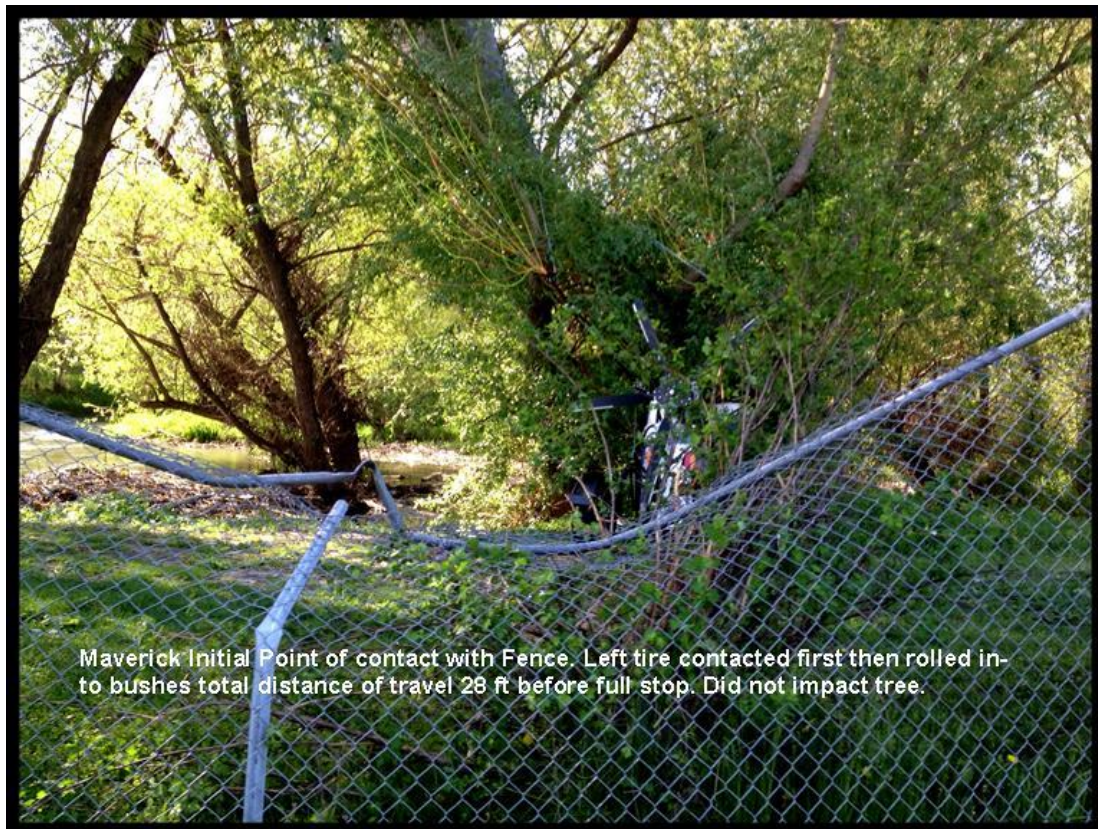
Maverick Initial Point of contact with Fence. Left tire contacted first then rolled in- to bushes total distance of travel 28 ft before full stop. Did not impact tree.

Picture 020 View from fence of direction of impact

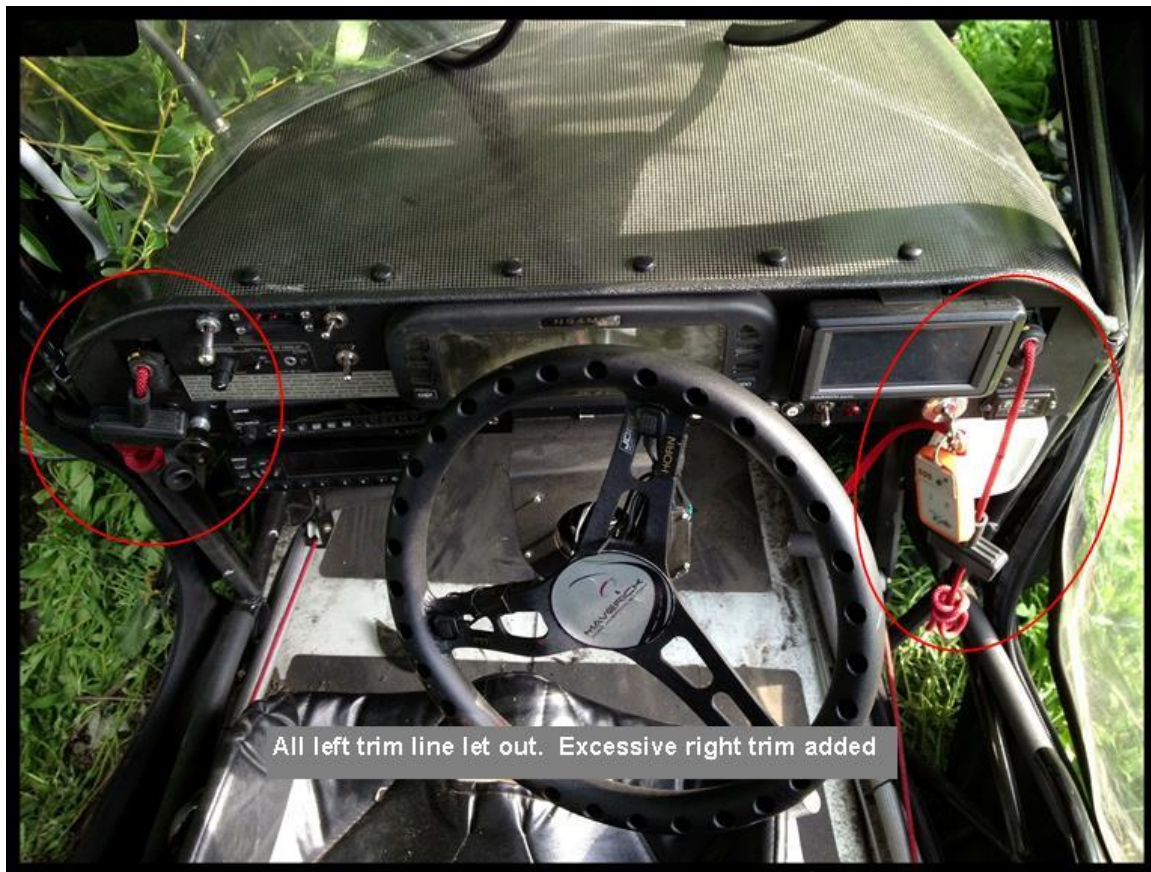
Picture 021 Line trim positions at time of accident
