This report prepared by Troy Townsend and Ray Siebring on May 17, 2013

The Aircraft

Category: E-LSA
Builder: Raymond Siebring / Aviation Education Initiative
Manufacturer: ITEC
Model: Maverick SP
Serial #: MS9003
FAA Registration: N94MV
Aircraft Total Time: 54.2 Hrs.

Investigation and Analysis

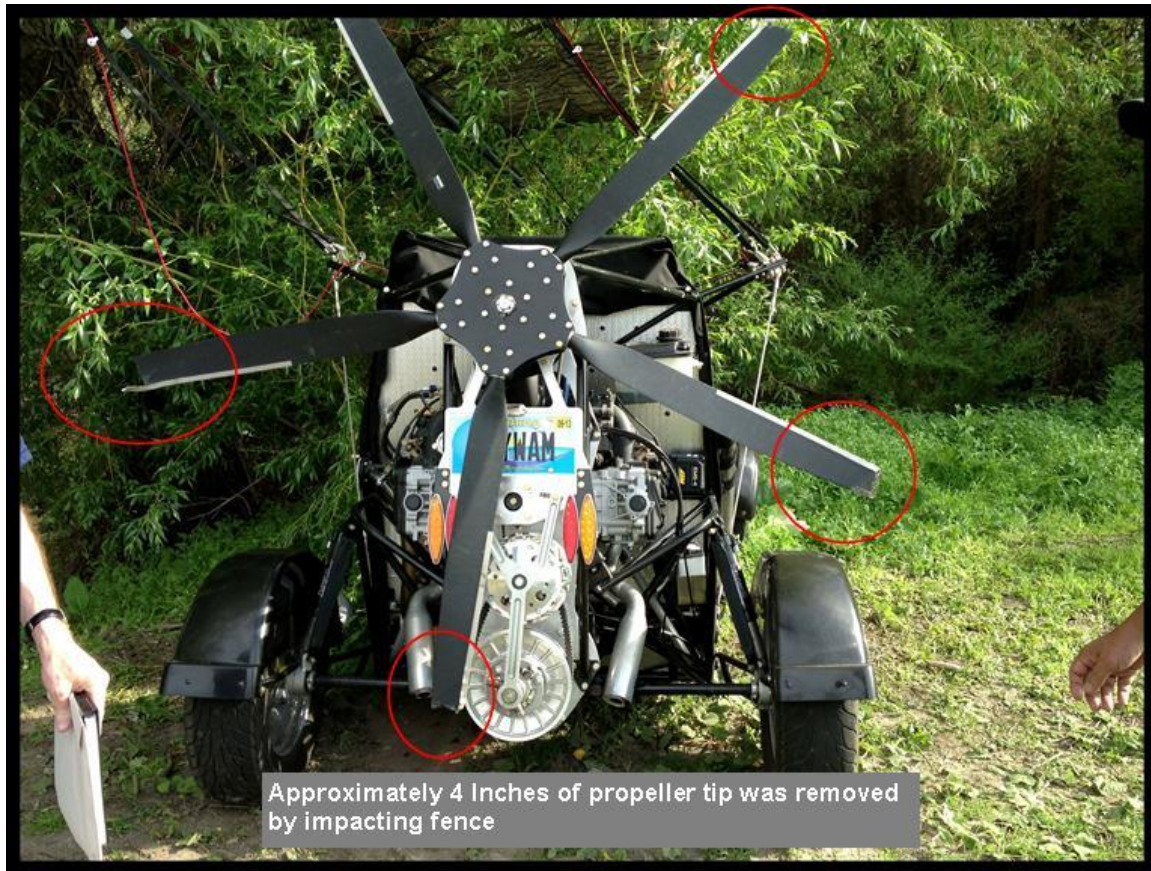
Picture 022 Propeller Tips separated by contact with fence

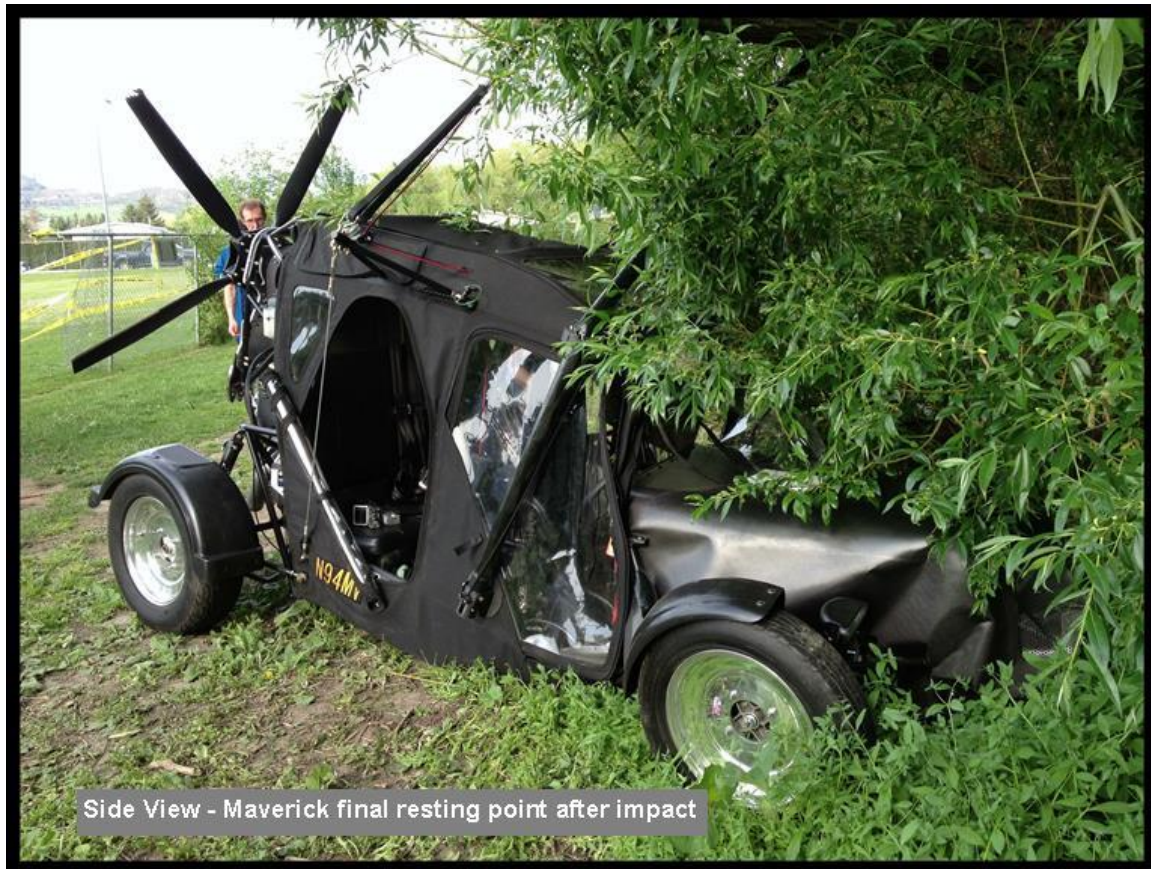
Picture 023 Side view of Maverick post impact
